**Monhegan
Museum of
Art & History**

White Paper

Creating a Sustainable Preservation Environment

Project Director: Jennifer Pye
Monhegan Historical & Cultural Museum Association
February 15, 2019

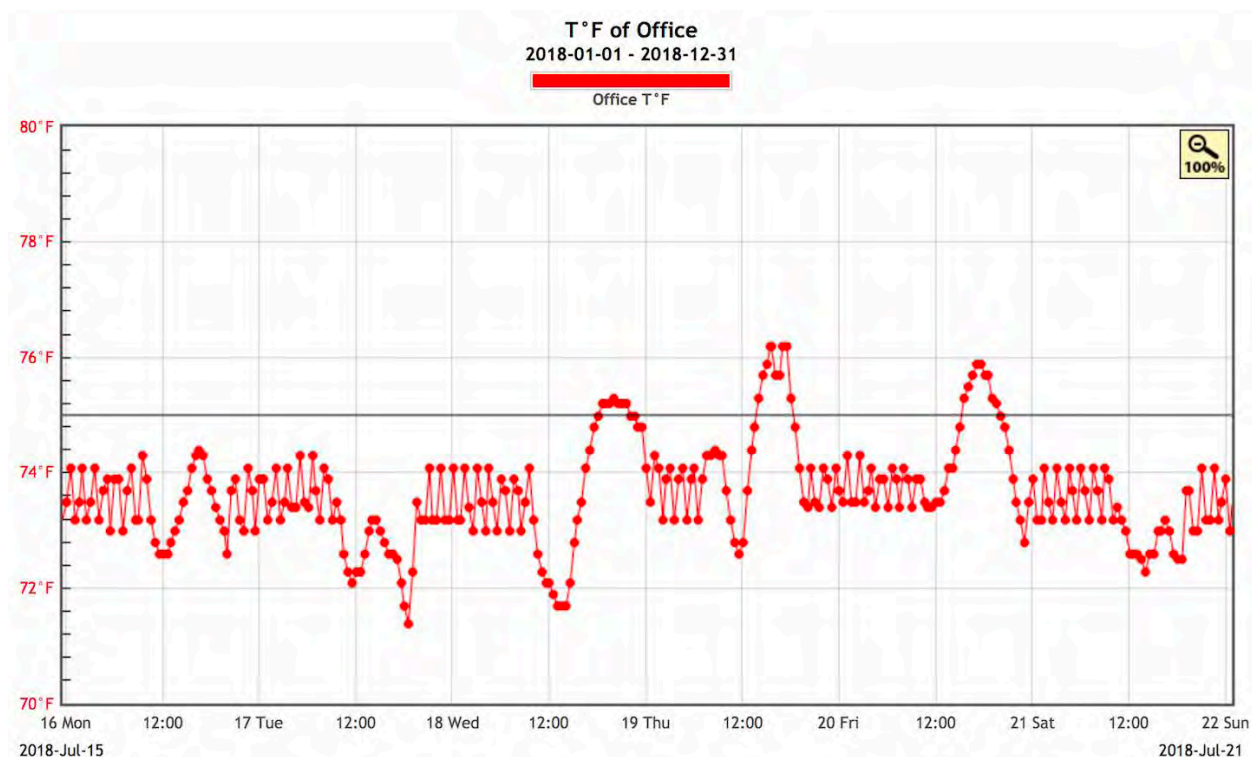
Summer operation was largely successful in keeping the temperature below 75F, with the spike in early August 2018 likely attributable to the power plant issues and chiller unavailability. One concern is that the summer temperature pattern in the office shows a regular sawtooth throughout the day – while this behavior is common in DX/refrigerant based systems, in a chilled water application it may indicate alternating behavior between cooling and heating. Without mechanical data it is difficult to say what the actual behavior was, but the team should review the current control and look for potential causes. While the overall control generally meets the environmental requirements, if the unit is regularly heating to maintain the condition, it will increase the overall energy expenditure.

Office, T Graph - Summer 2018. Sawtooth pattern may indicate alternating behavior between cooling and heating.

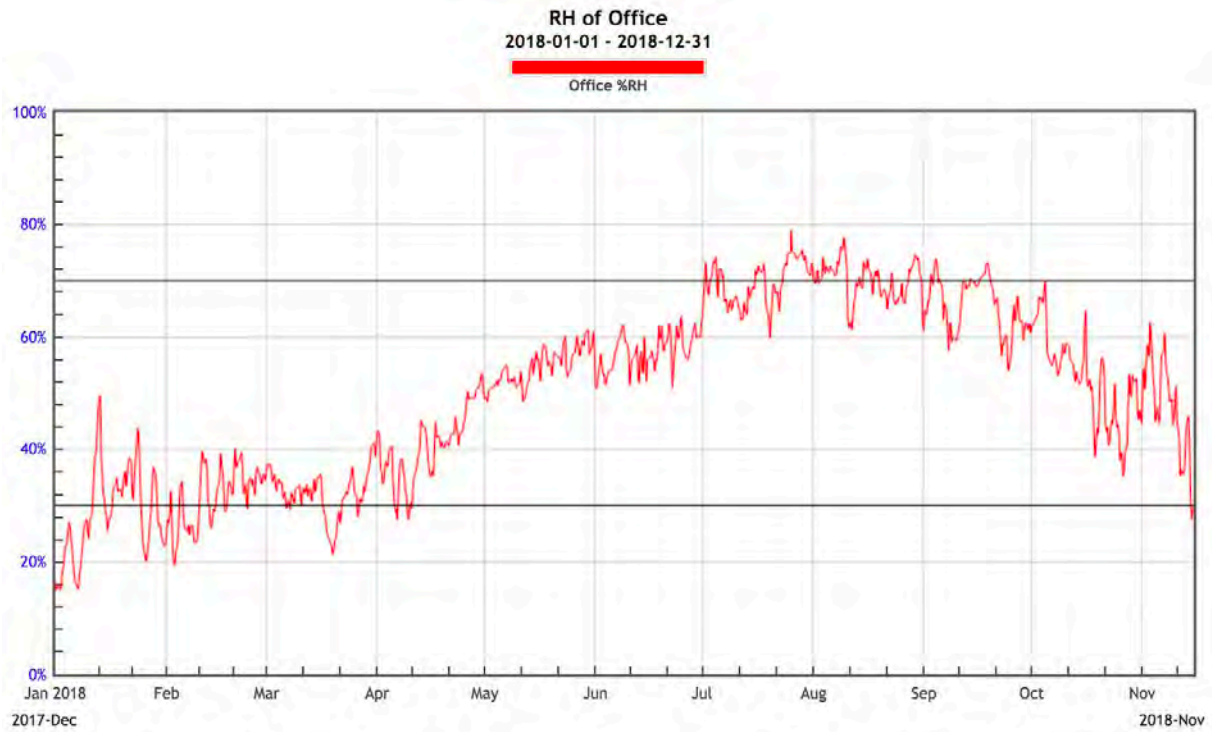
RH control exhibited the same operational issues as the Gallery and the Vaults, with no discernible set point maintenance and a dew point that appeared to fluctuate rapidly in response to outdoor conditions. Like the Office, the presumption is that the dehumidifier was actively running throughout the summer. By mid-summer, RH conditions were regularly exceeding 70%, although not for periods long enough to encourage mold germination. These conditions create a risk for both mechanical damage as well as silver oxidation in the photograph collections.

Office, RH Graph - 2018. Summer conditions rarely drop below 60% RH with regular operation above 70%.

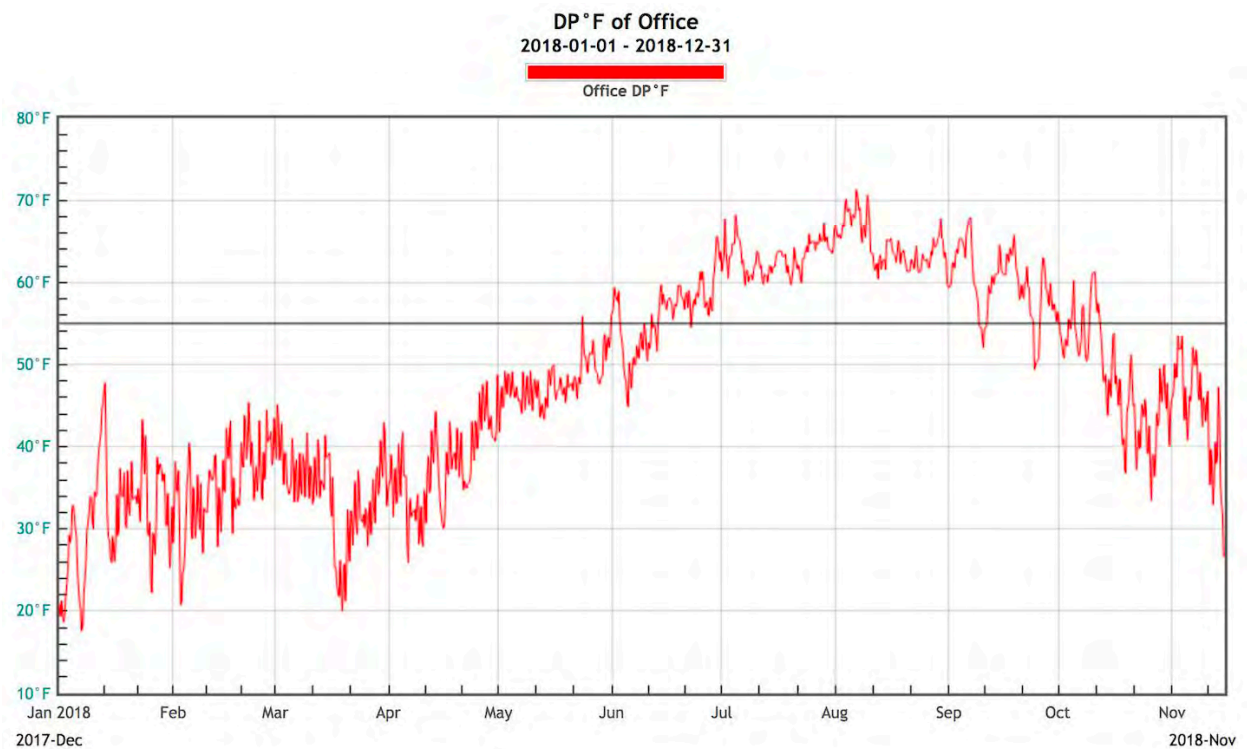
Office, DP Graph - 2018. The limit-line indicates the likely interior dew point at a 72F/55% environment.

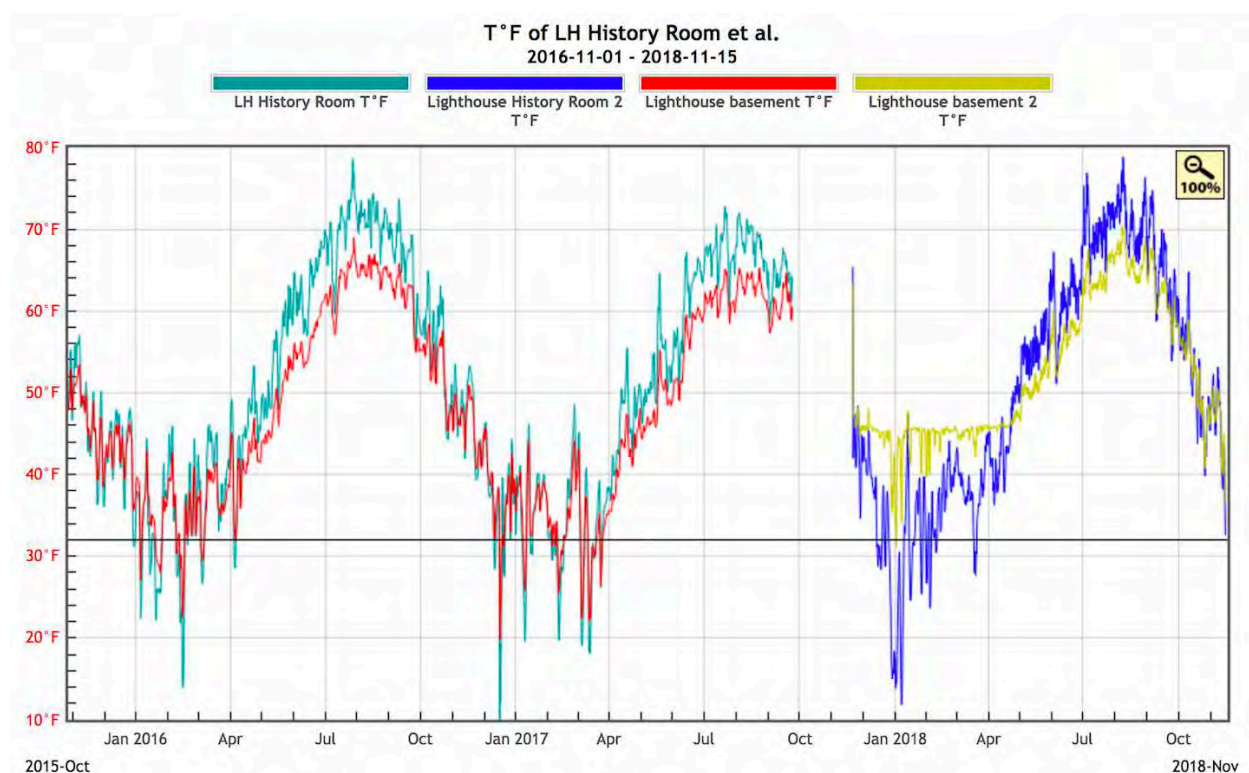
The impact on the basement temperature over the winter months is clear – basement temperatures (red and yellow plots below) have traditionally run between 30-40F, with significant time spent below freezing each winter. In 2017-2018, the basement temperature stayed consistently above 40F, with the exception of the cold front over the new year period.

Keeper's House, Basement T - 2015-2018. Basement conditions are red/yellow plots, teal/blue plots are for the History Room.

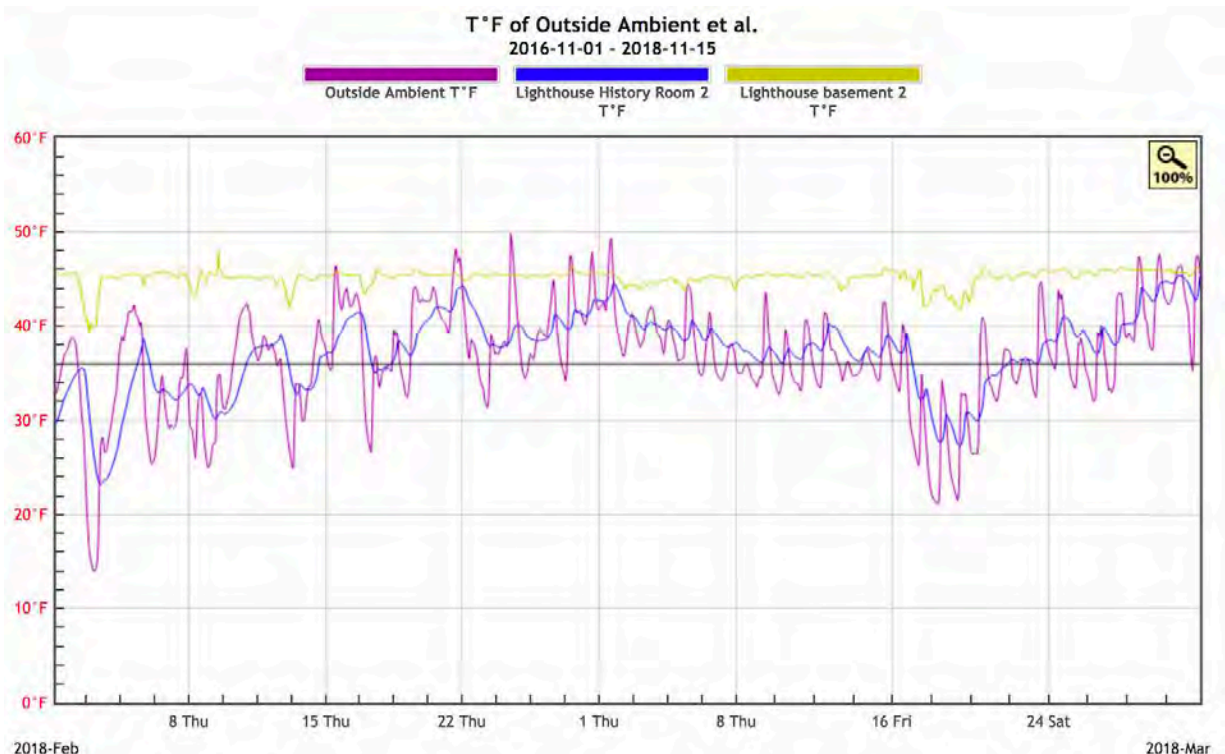
The impact on the floor above – the History Room area, is less clear. The first-floor temperature trends consistently higher in February-March 2018 than it did in years past, but it is difficult to tell how much is the influence of exterior conditions, and how much may be the basement heat. An overlay of the available outdoor data shows that the History Room temperature in February-March 2018 was much more muted in response to outdoor temperature swings that it had been in years past. Previous years showed the History Room responding quickly to outdoor conditions, with temperatures indoor nearly as cold (or warm) as those outdoors. The influence of the heat seems to have kept the History Room anywhere from 3-10F warmer than outdoor conditions, which was new behavior compared to the winters of 2016 and 2017.

Keeper's House, T Graph - Winter 2018. Note the muted behavior of the History Room temperature (blue plot) compared to the outdoor air condition (purple).

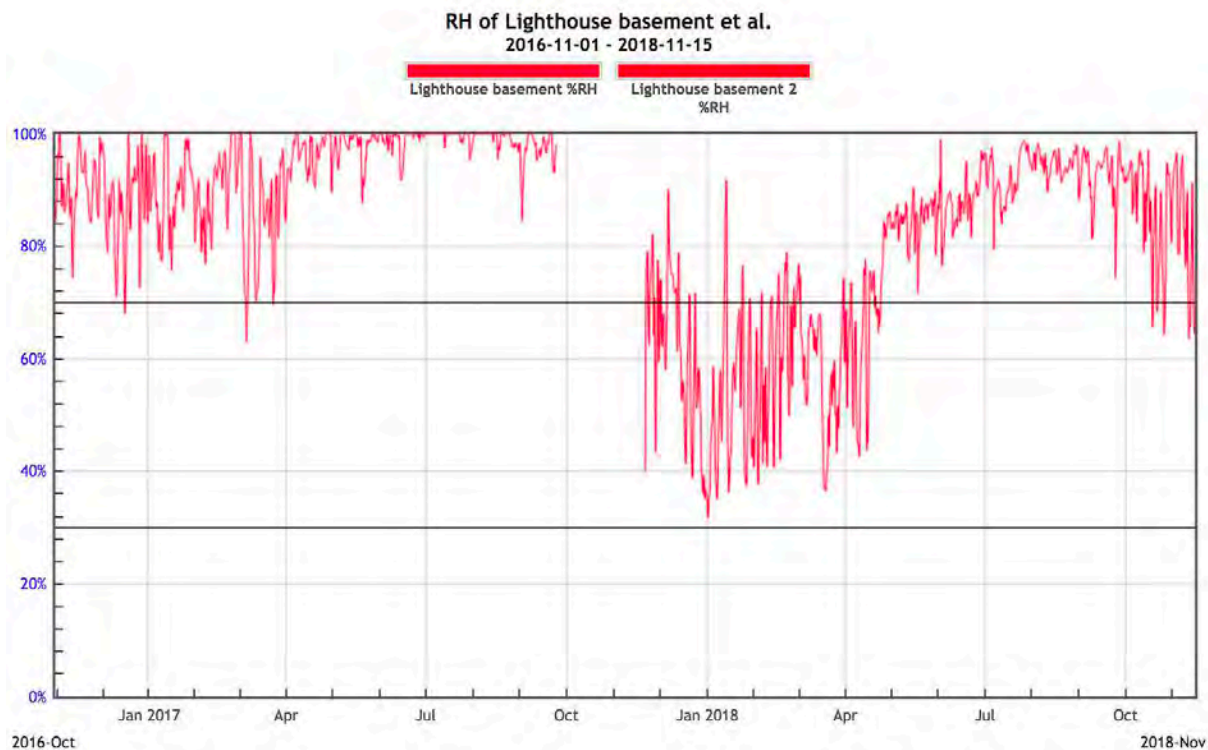
In various conversations over the period of the project staff noted that the cleaning mold off of the walls of the Keeper's House, particularly in the several of the first-floor rooms, was a typical task each spring. The impact of heating the basement is clear in the basement RH graph – RHs drop from conditions between 80-100% in the winter of 2016-2017 to only occasionally going above 70% in the winter of 2017-2018 (see below graph). This had a significant impact on the risk of mold growth in the basement – conditions went from regular risk of germination in winter 2016-2017, to no risk at all in 2017-2018. While there are still issues with high RH and potential mold growth during the summer months, the addition of heat in the winter effectively lowered RH and mold risk in the basement area.

Keeper's House, Basement RH Graph - 2016-2018. Note the low RH in winter 2017-2018 compared to the previous year.

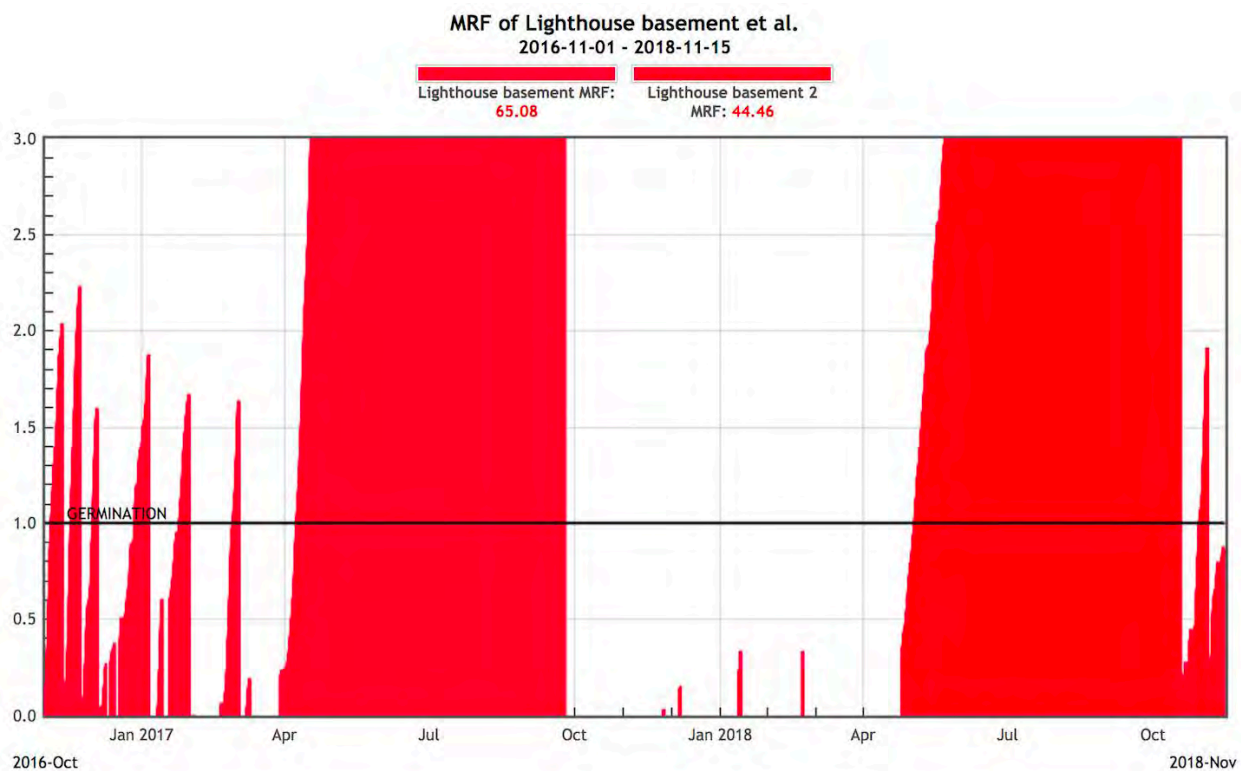
Keeper's House, Basement Mold Risk Factor (MRF) - 2016-2018. Note no mold risk factor in winter 2017-2018 compared to the previous year.

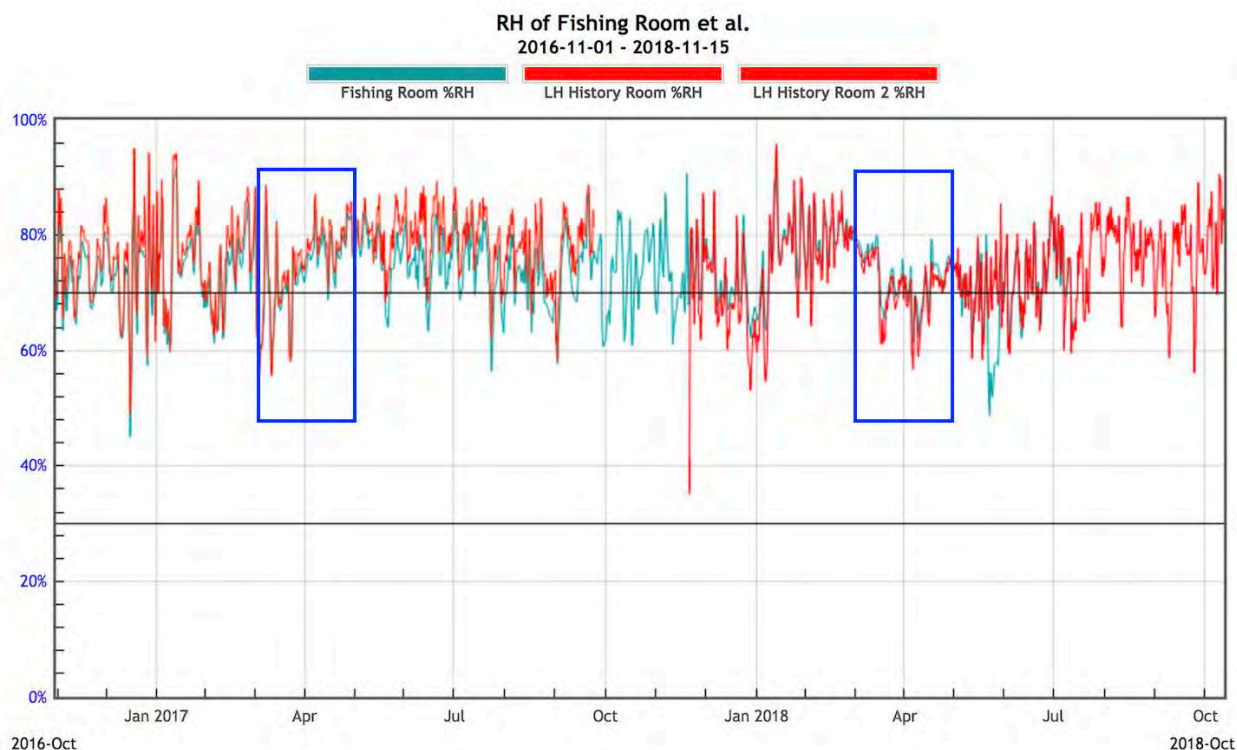
RH on the first floor History and Fishing Rooms did not respond as drastically – comparing months in winter 2016-2017 to those in 2017-2018, RH conditions are generally lower in November-December 2017, but the January-February 2018 conditions appear quite similar to the previous year. The key to the lack of mold growth in spring 2018 appears to lie in the March-April 2018 conditions, which are noticeably lower than those the previous year.

Keeper's House, First Floor RH Graph - 2016-2018. In the outlined boxes, note the lower RH conditions in 2018 compared to 2017.

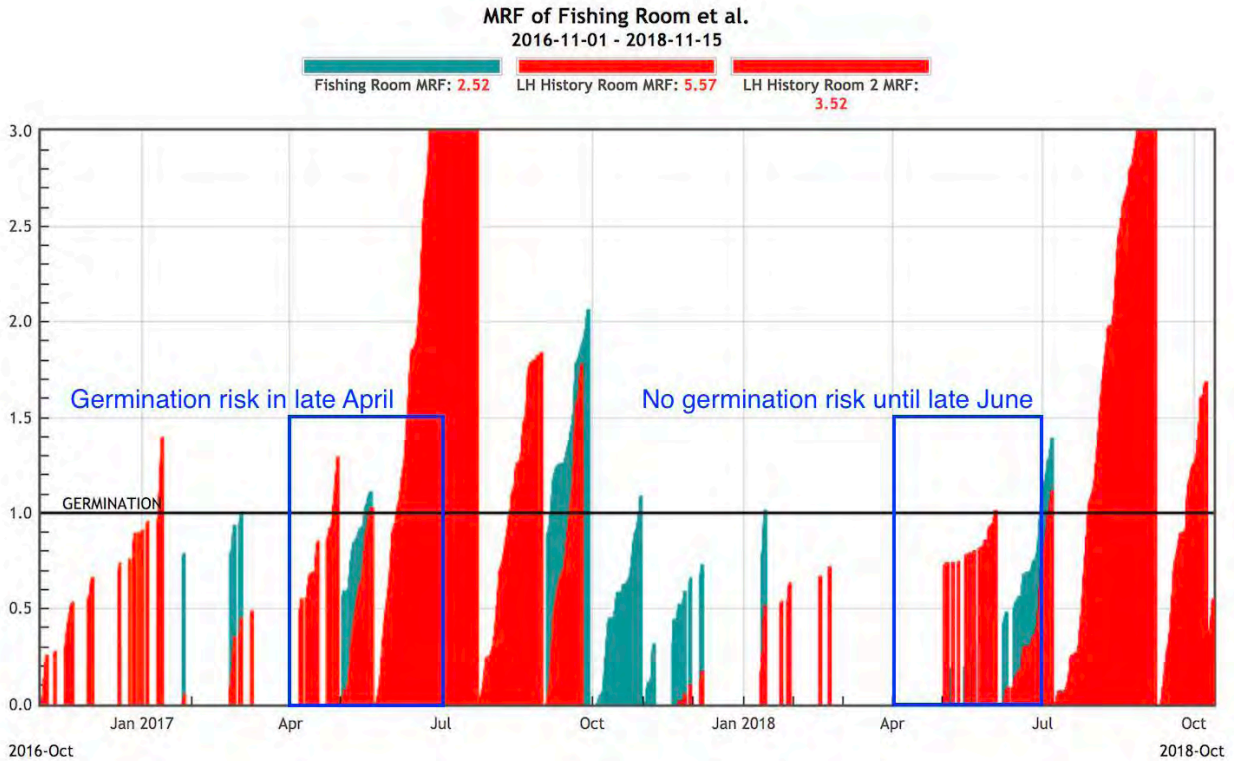
Though there are multiple variables that could have caused the lower RH condition, many of the structural improvements had been completed prior to the winter of 2016-2017, with the additional of the basement heat being the key difference between the two data periods. While the difference is clear, the 2018 RH still does not seem quite low enough to limit mold germination – conditions are still regularly above 70% RH, and were previously high for much of January and February. Inspection of the Mold Risk Factor graph and algorithm reinforce the lack of visible mold growth in spring 2018 – even though RH conditions still seem high, the MRF is sufficiently below germination points for the entire winter of 2017-2018, and do not reach risk levels until late June 2018. Though the Museum should continue to document any observed mold each spring as well as review environmental data for indications of risk, the available data thus far indicates that the decision to add minimal heat to the Keeper's House basement likely played a large part in limited mold growth on the first floor of the house in Spring 2018.

Keeper's House, First Floor MRF Graph - 2016-2018. Germination risk in spring 2018 is significantly less than in 2017.
